# Manhole Inspection Summary

Manhole # S35SS1014MH

Insp Date: **3/29/07 9:20 AM**

**Location** Address: **431 NOTRE DAME LN**

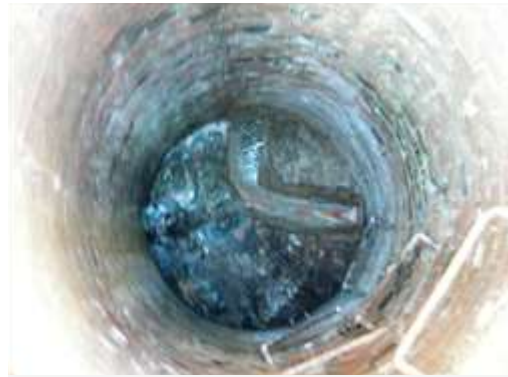
Top View

Bench debris.

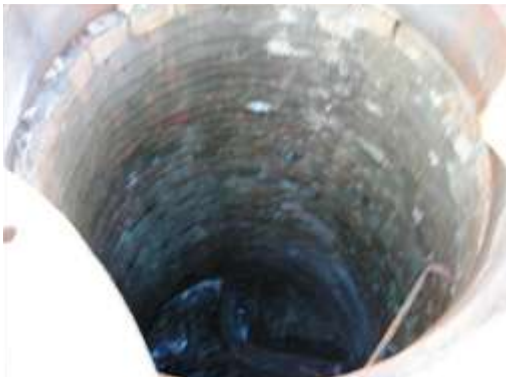
Defect

Frame leaks. Adjustment deterioration, loose brick and infiltration. Corbel and Barrel infiltration - other side.

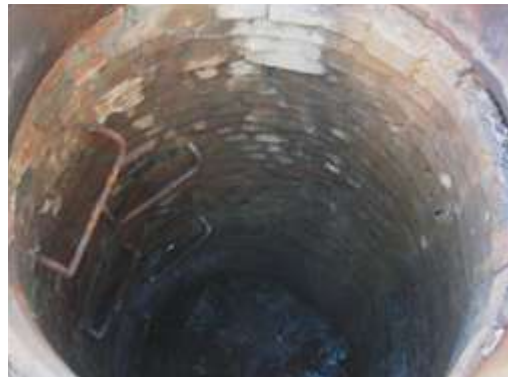
Defect

Frame leaks. Adjustment deterioration, loose brick and infiltration. Corbel infiltration.

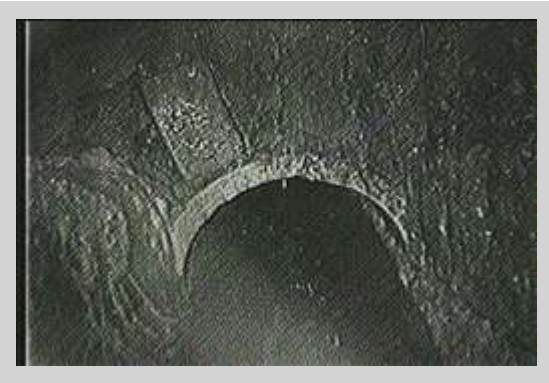
### 8 in. Circular Gravity Sewer Pipe Out @ 12 O'Clock

Infiltration: **None** Pipe Seal Cond: **Cracked**

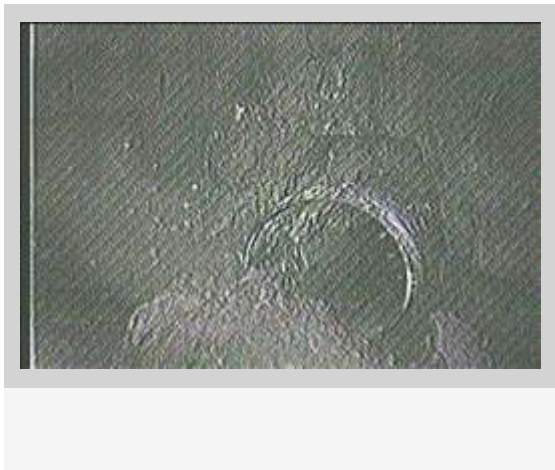
6 in. Circular Gravity Sewer  
Pipe In @ 9 O'Clock

Deposits: ☐ None ☐ Mud ☐ Sludge ☒ **Debris** ☐ Grease

Silt Depth: **0** (in.) Deposits Extent: **Heavy**

Infiltration: **Evidence** Pipe Seal Cond: **Broken**
